Cast Iron Repairs by Gas Fusion Welding

FRACTURES • CORROSION • EROSION

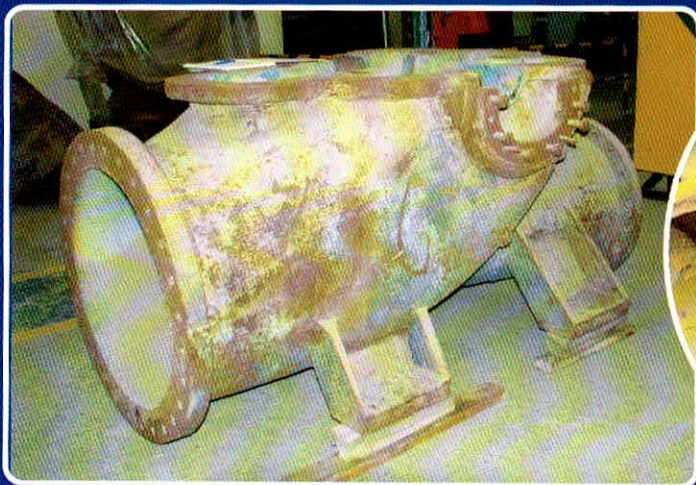
One of seven high-lift seawater pump housings with extensive internal erosion to both wear ring and stuffing box locations.

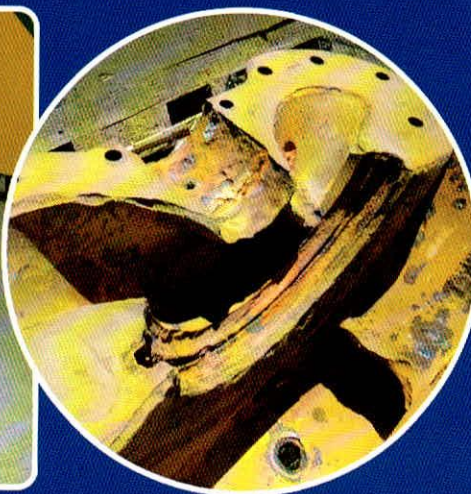
Wear ring and stuffing box locations rebuilt by gas fusion welding utilising material identical to the parent metal.

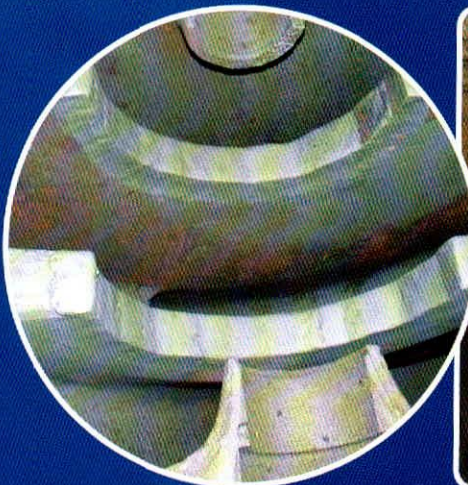
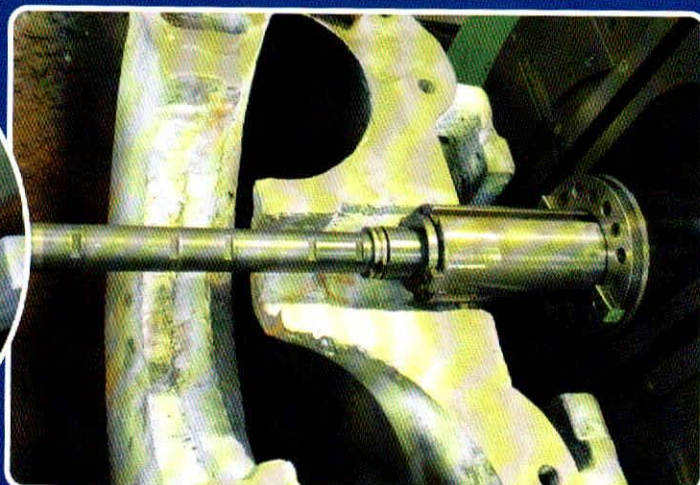
Wear ring location machined to original profile, stuffing box area machined to accommodate mechanical seal upgrade.

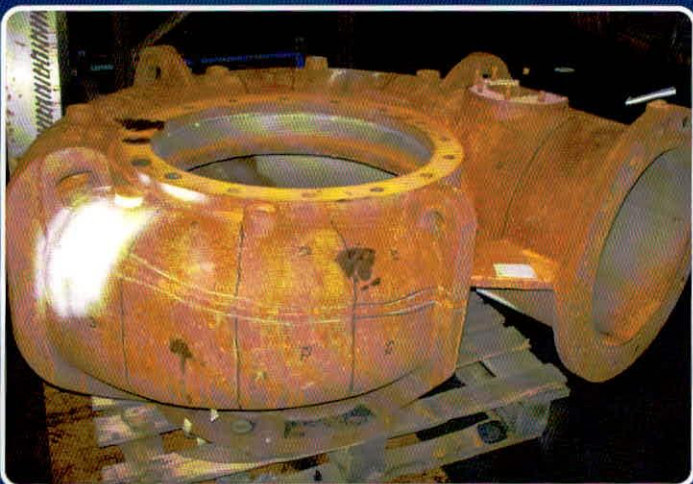
Due to the age of the component and the environment in to which it was to operate it was decided to further enhance the repair by the addition of strengthening ribs to the outer of the discharge channel.

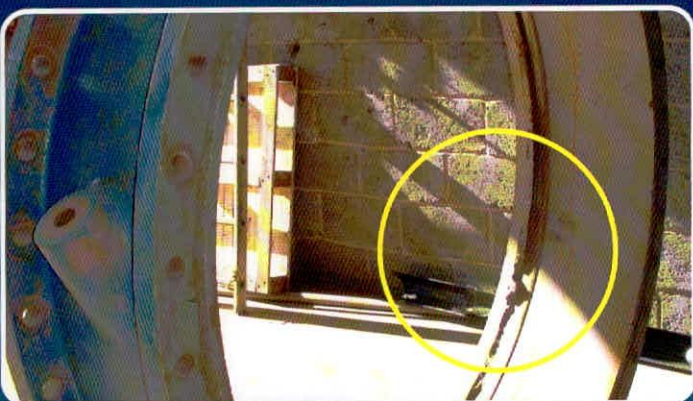
This butterfly valve had extensive erosion around its sealing areas. These were gas fusion welded ready for machining back to its original profile.

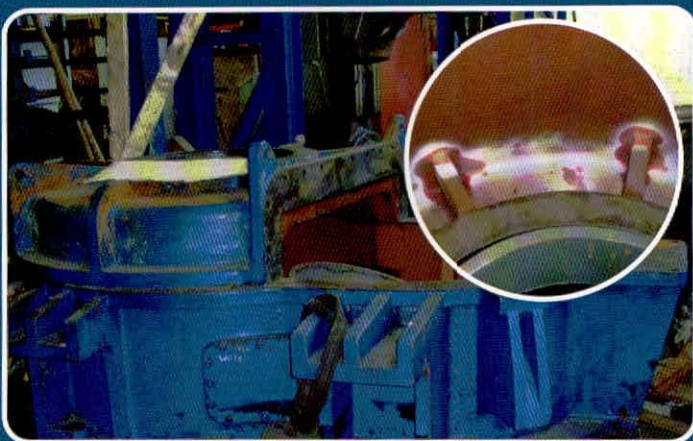
Gearbox with cracked internal webs which have been restored.

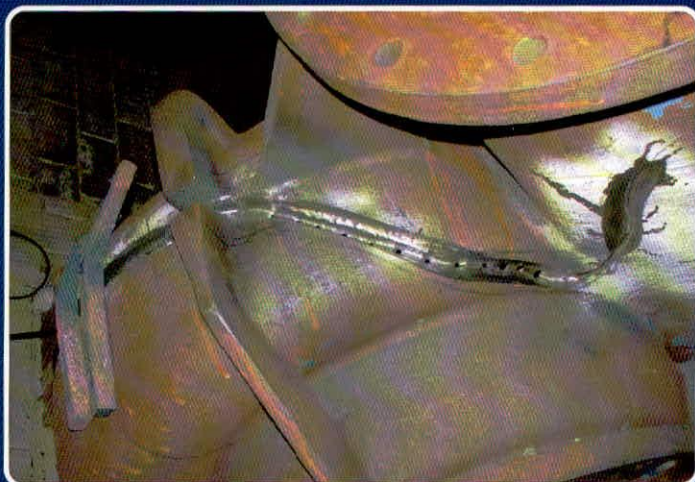
The component is then prepared for welding by removed the crack in it s entirety and to then establish a firm base of sound parent metal upon which to commence the welding process.

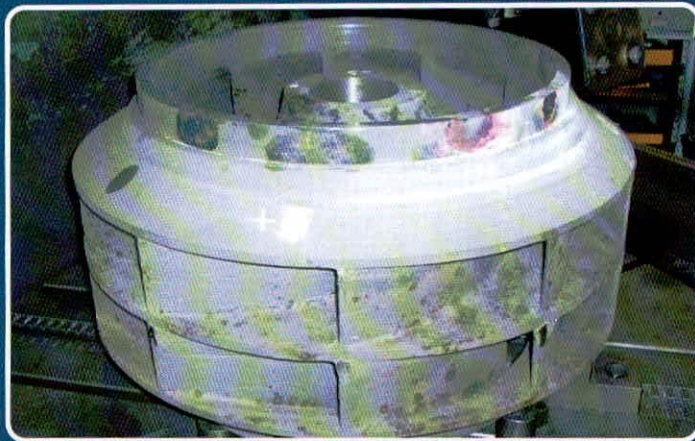
The blades of this impeller have been built up with gas fusion weld, then machined back to the original profile.
