# Wartsila 46 Cylinder Head

## Valve seat pocket repairs

## Cross bore cooling channel repairs

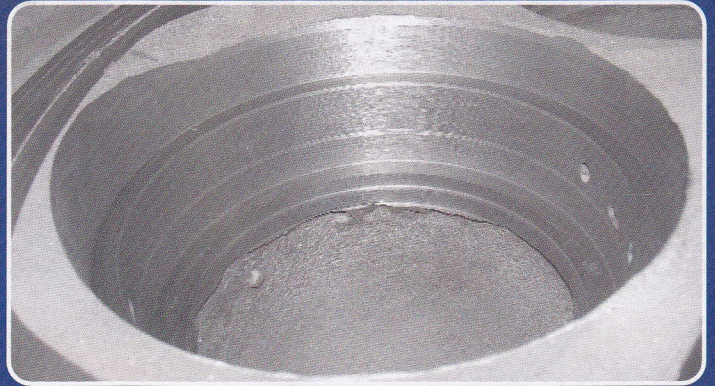
Exhaust seat pockets machined and restored back to standard size.

Cast Iron Welding Services can rebuild the valve seat pockets, machine them to their original dimensions and fit standard size valve seats as used on the head when new.

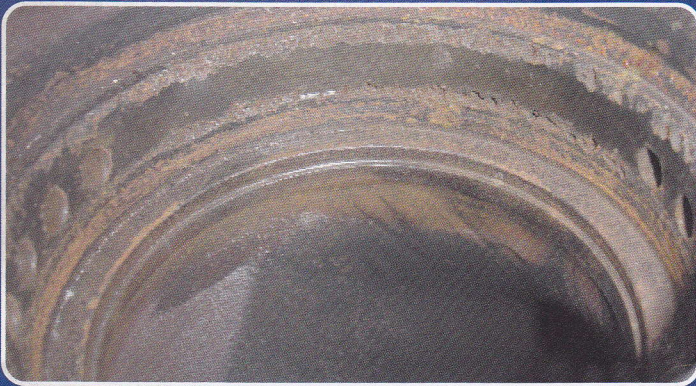
The most common repair required on the R46 cylinder head is valve seat replacement, caused by erosion from coolant leaking between the seat and pocket. When the last oversize seat has been fitted and needs replacement, the head is no longer serviceable.

This picture shows eroded exhaust seat pockets having gone beyond the last standard oversize.

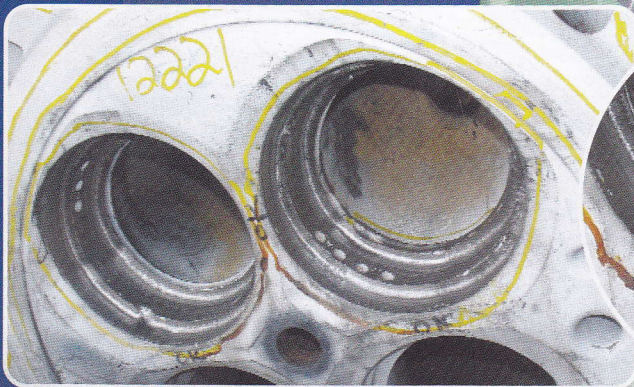
The seat pockets prepared prior to welding.

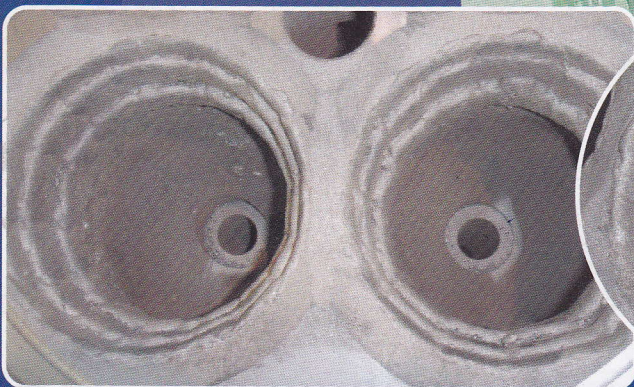
The seat pockets rebuilt.

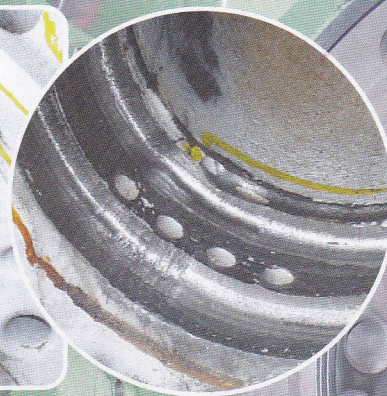
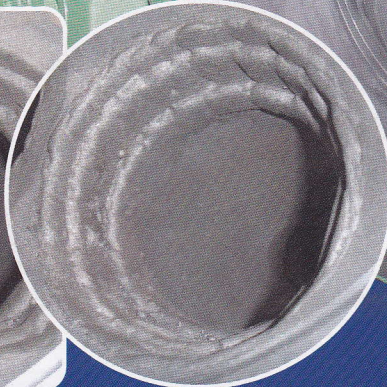
Tested, classification approved, ready for despatch.

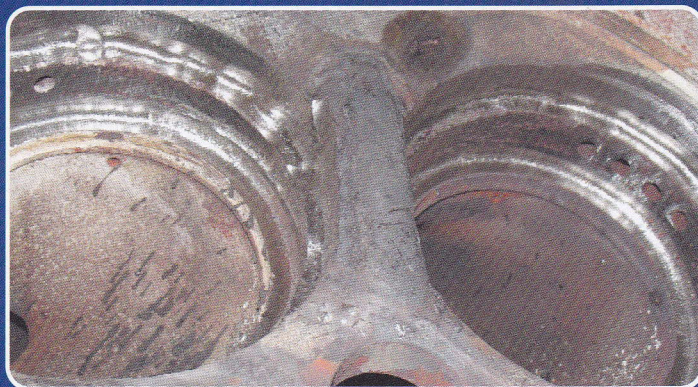
Weld repair stage 1: Repaired cross bore cooling channel.

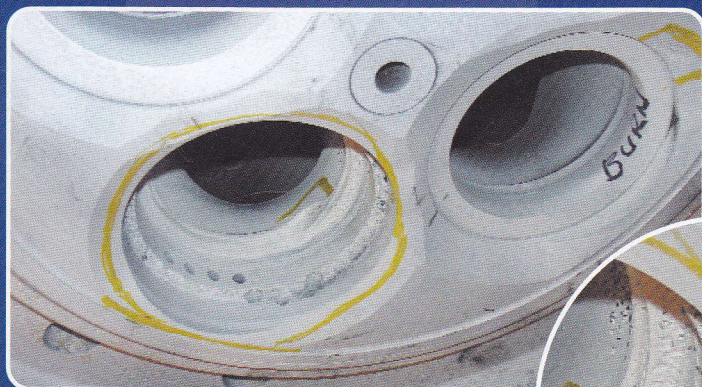
Some Wartsila R46 applications cause the cross bore cooling channels in the flame plate to corrode, eventually damaging the valve seat pockets. We remove the corroded areas completely, rebuild the cooling channels and machine them back to original dimensions.

Here corrosion has broken through into the valve seat pocket from the cross bore cooling channels.

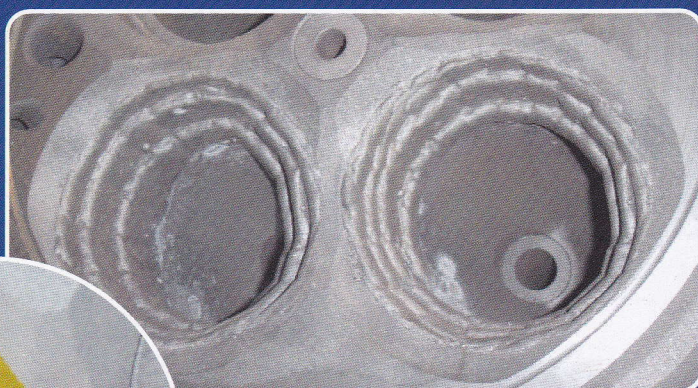
Weld repair stage 2: Repaired valve seat pockets.

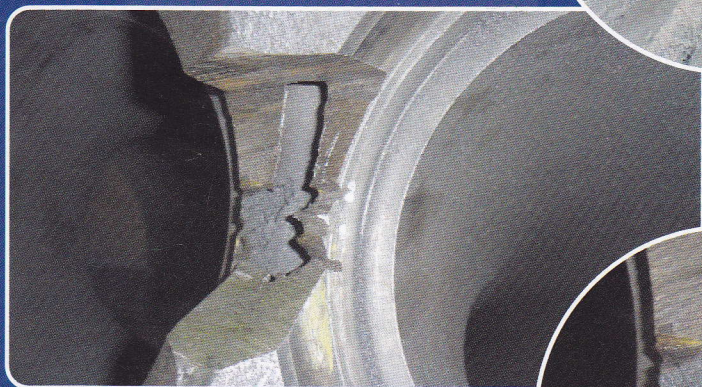
Corroded cross bore area removed.
