Veteran, vintage and classic motor vehicle casting repairs

For the restoration of cast iron components for steam engines and vintage vehicles

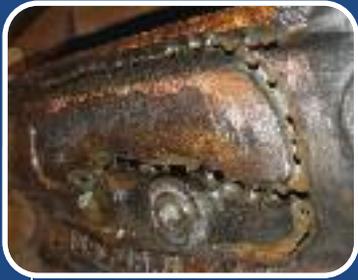
Jaguar 3.8 Litre block with water jacket corrosion damage.

The damaged area was ground out, cleaned up and gas-fusion welded with new metal. The repair was blended in to the original contours and the Jaguar logo rebuilt.

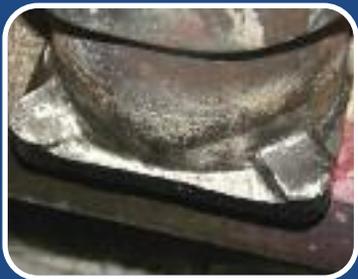
This veteran cylinder/head casting had suffered broken flanges. Both flanges was rebuilt with gas-fusion welding and machined back to standard specification.

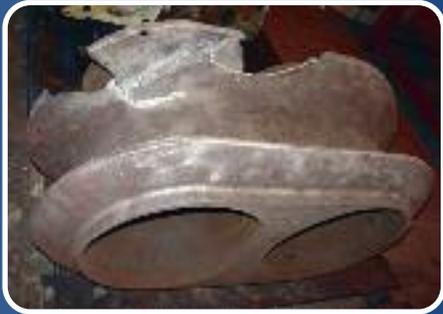
This double chimney stack casting was broken and had been poorly repaired. We replaced the missing sections of the casting, blending the new metal into the original and gas fusion welded the cracks. The stack is now serviceable again.

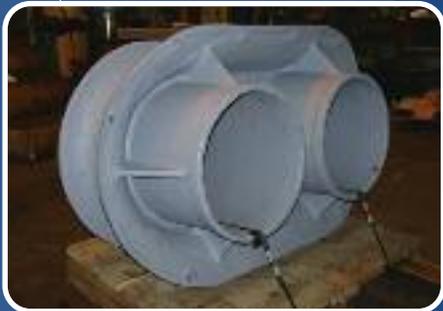
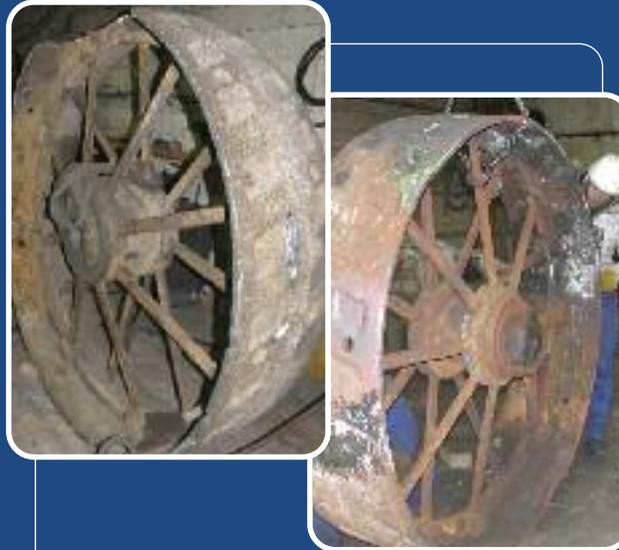
This traction engine wheel has suffered extensive cracking with large sections missing. The internal wrought iron supports were checked and re-welded into place using the gas-fusion process. Patterns were made for casting new sections from material of the same chemical analysis and welded into position.

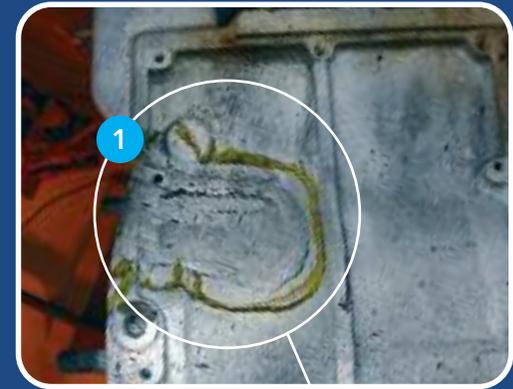
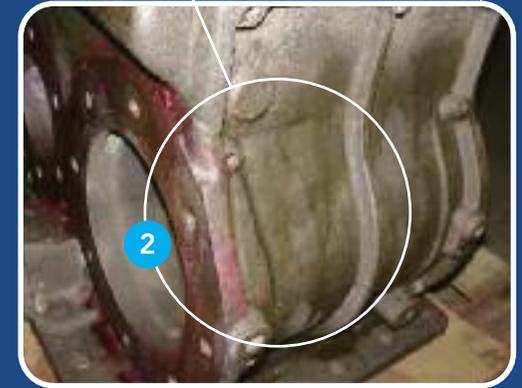
- 1** The heat from a poor arc-weld repair on this cylinder block has caused hardened areas and several horizontal cracks leading from the weld deposit. This poor weld has exacerbated the repair process. A virgin fracture would have been much simpler to gas fusion weld.
- 2** The hole adjacent to the repair on the bolting face had to be gas fusion welded and drilled. Picture 2 shows finished repair ready for fitting after testing.
