Heritage restoration Audley End sluice gates

1802 cast iron bridge supports

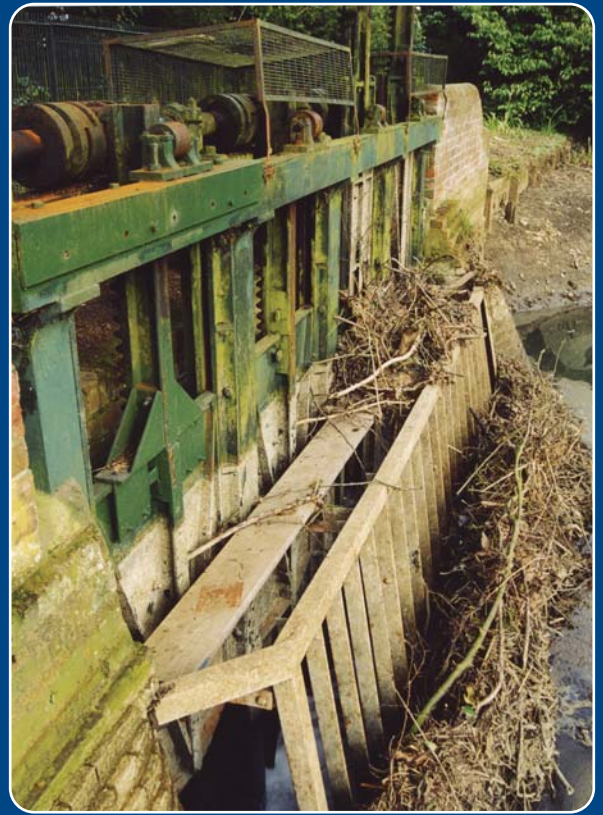
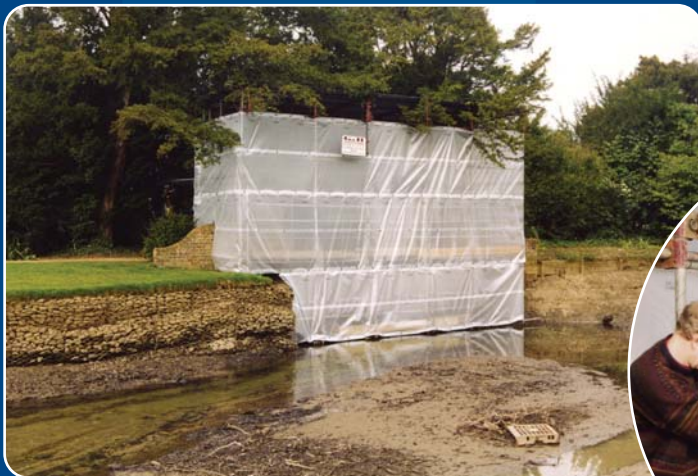
Audley End House sluice gates were found in a very distressed condition with seized barrier sections, broken gearing, main-shaft seizure and severely restricted waterway relief.

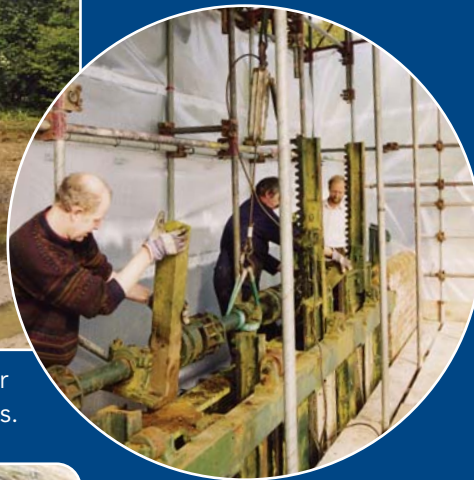
Scaffolding and weather-proofing were erected over the site to comply with health and safety regulations.

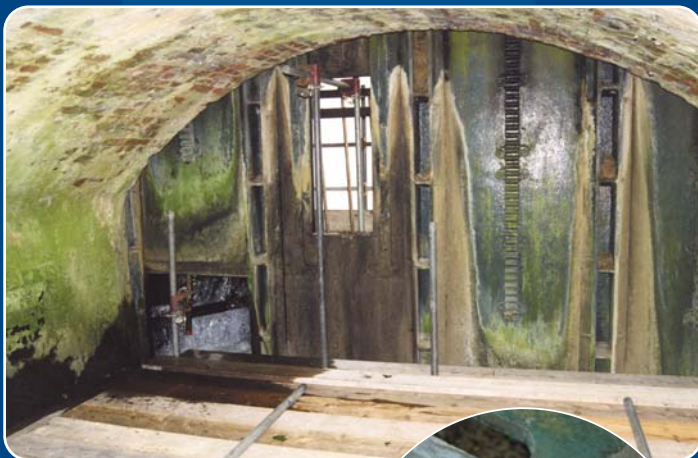
The removal of the top section of the sluice gates including gear components and downright supports.

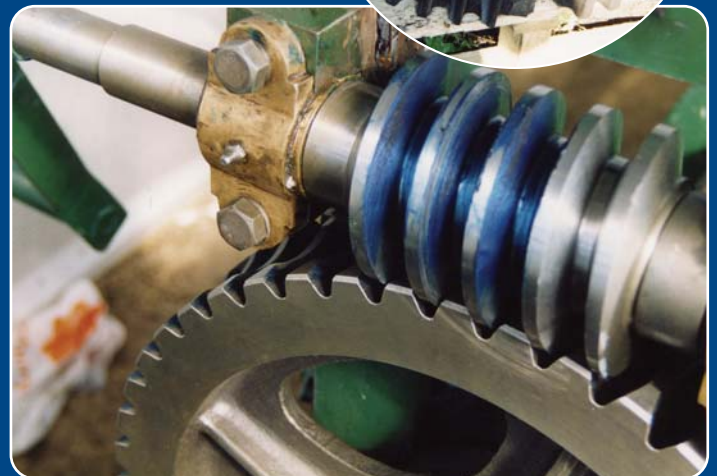
The original gearing proved to be badly damaged. New gears with improved ratios were manufactured and installed by Cast Iron Welding Services.

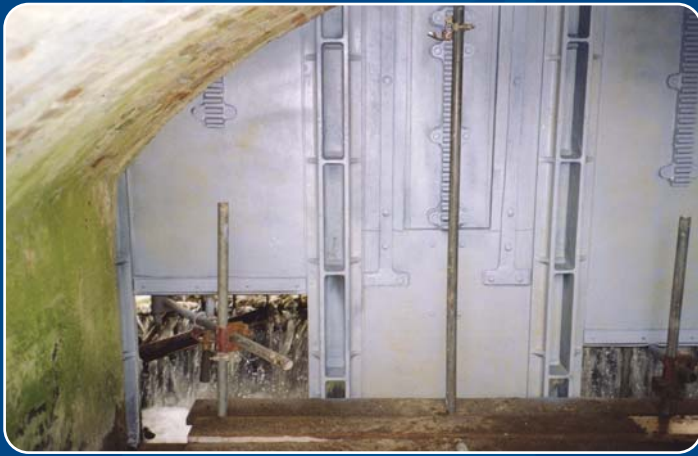
Re-fitted sluice gate section viewed from inside the bridge.

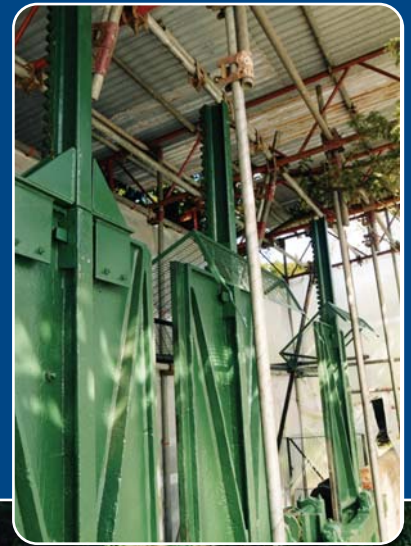
Re-fitted gearing, main-shaft and bearings. Note: the gates have been manually opened to a height of 5 meters with the aid of the newly fitted gear ratios.

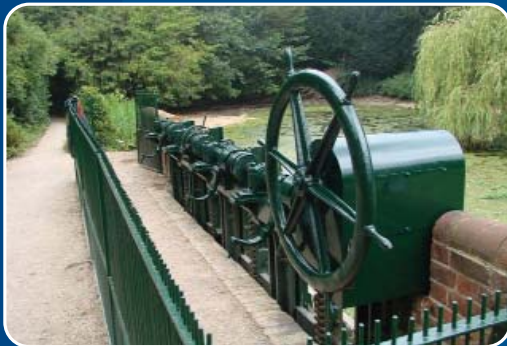
Completed sluice gates with restored mechanism and guards.

The newly finished gates viewed from the river bank opposite.

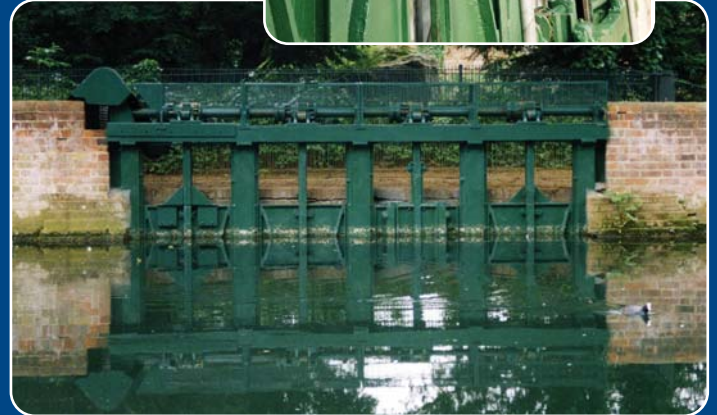
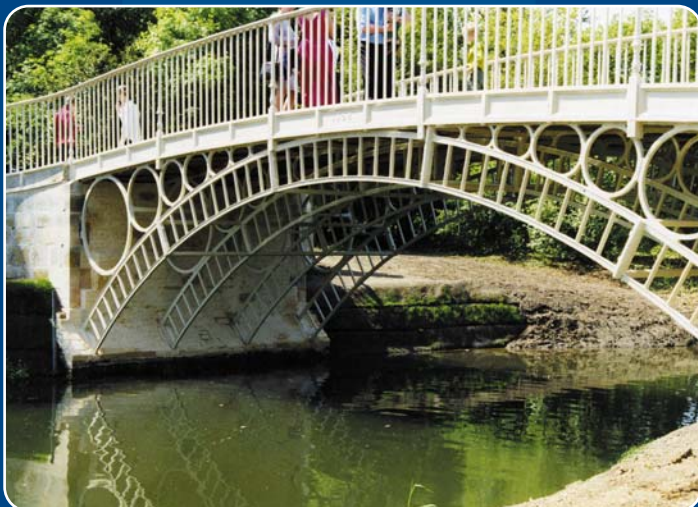
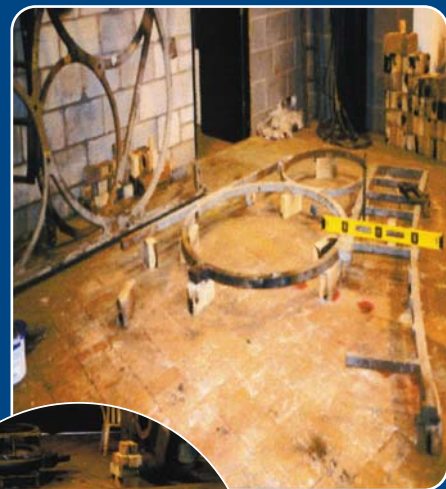
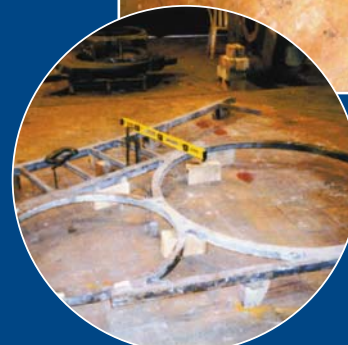
Restoration work to the bridge which dates back to 1802 required the repair of over 160 fractures using material identical to the parent metal.

The bridge was dismantled and the sections taken to our workshop. Each was stripped and inspected before restoration.
