Lamp Standard Repairs

Brighton sea front

Cast Iron Welding Services were asked to restore a number of decorative cast iron lamp standards on Brighton sea front. The lamps and columns had been removed leaving only the bases.

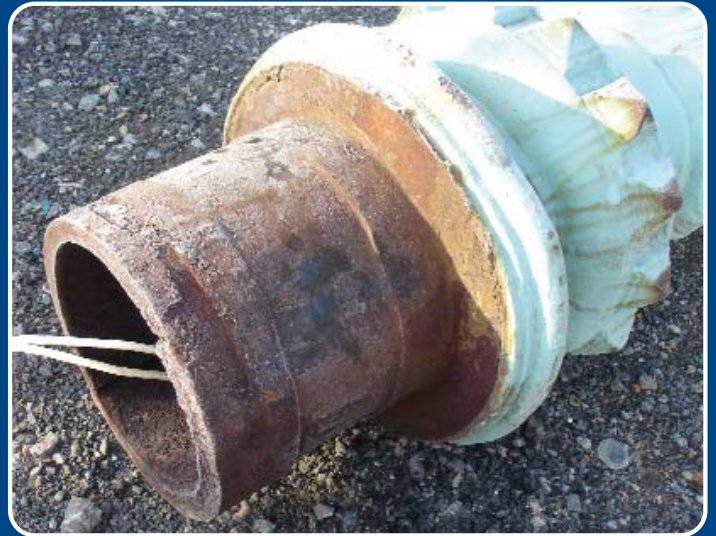
Spigots that locate the columns into the base's were worn, allowing the the lamps to rock dangerously.

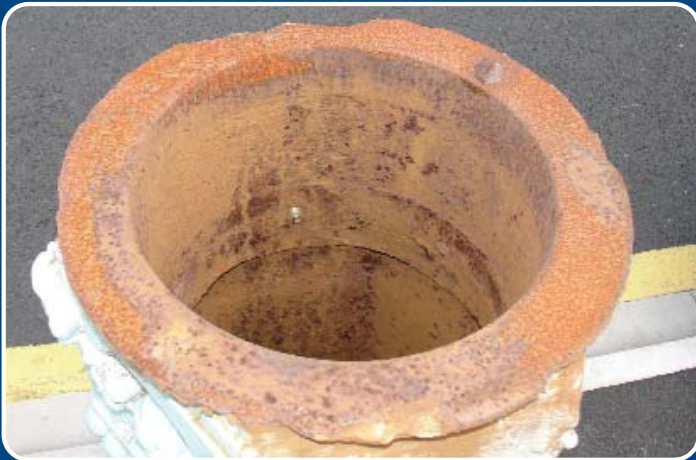
The base which receives the column is eroded and will require reaming out to accept the rebuilt and machined spigot.

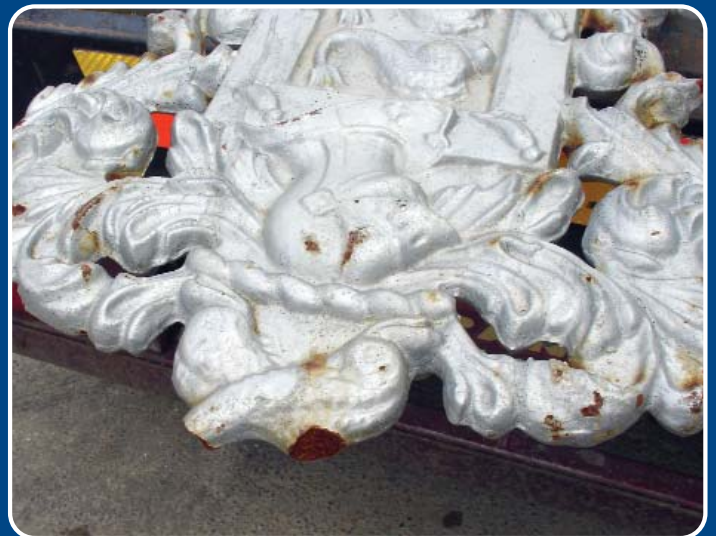
Each of the castings was assessed for damage and subsequently repaired at our workshops.

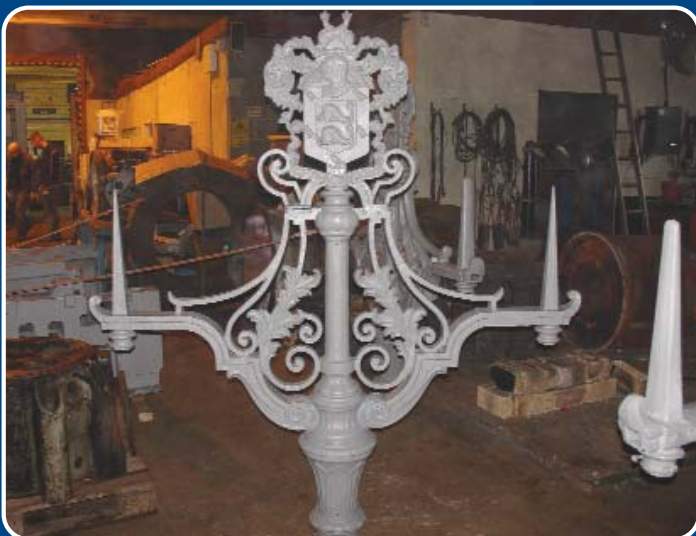
The castings were shot blasted, any damaged detail was built up with weld and re-contoured to original before being treated to a liberal coating of primer.

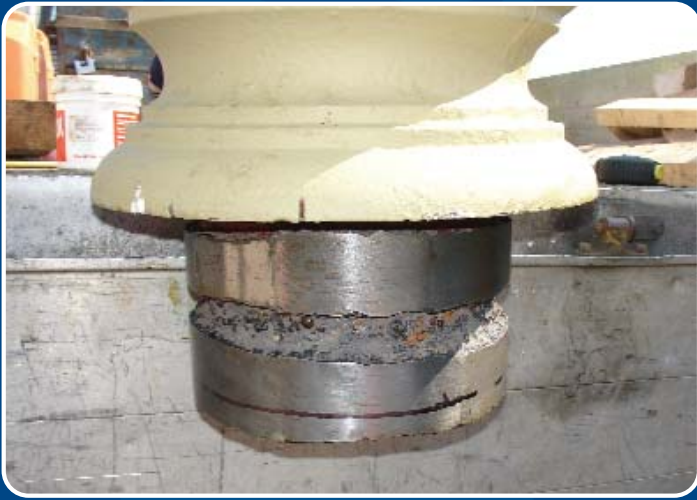
The column spigots were built up with gas fusion weld, and along with the mounting face, re-machined. The finished castings were then returned to site.

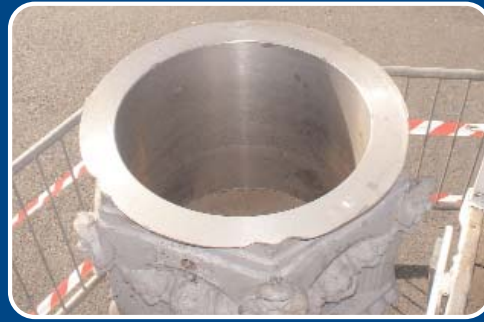
The finished lamp base.

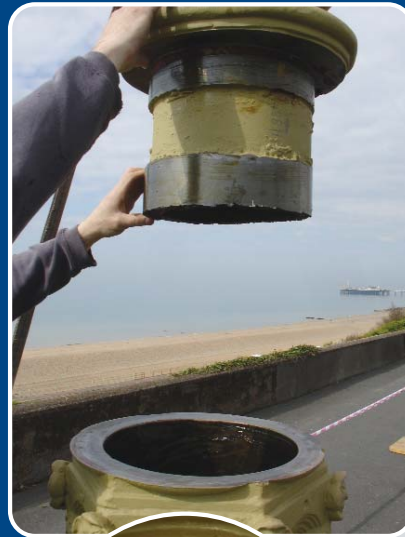
The column is lifted into position and the spigot is dropped into the base.

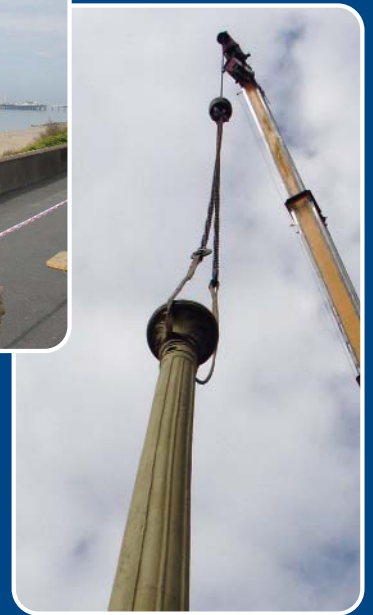
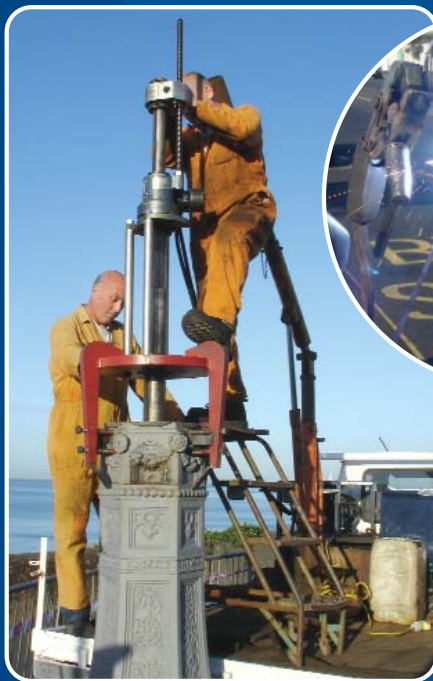
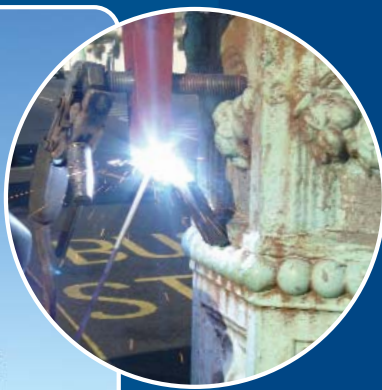
A specially designed reaming cradle was secured around each lamp base to aid accurate positioning of the reaming tool.

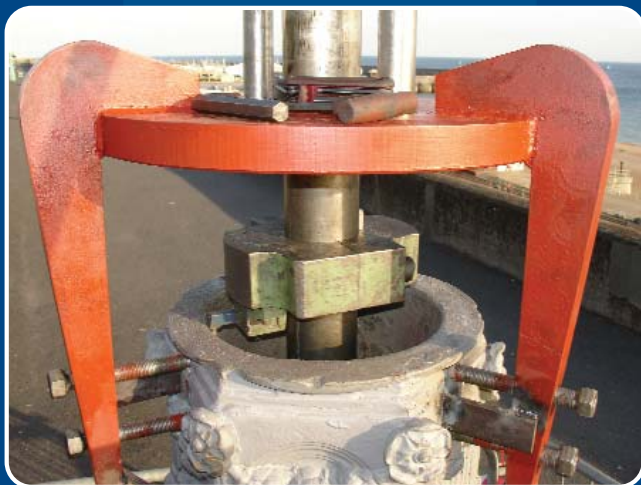
The reaming tool gets to work.

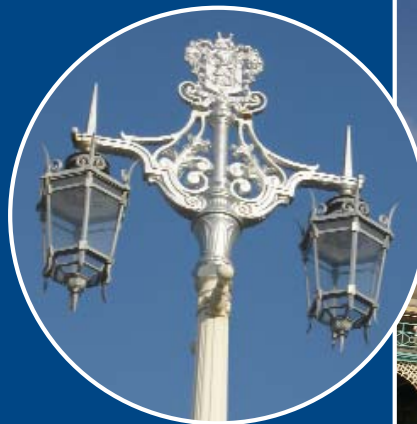
The finished job, the restored and re-painted lamp standards.
