Tower Bridge, London

Tower Bridge is one of London's most famous landmarks and probably the most photographed bridge in the world. Having stood for over a century, some of its cast-iron components are showing signs of decay. Cast Iron Welding Services were asked by London City Council to restore the balustrades and lamp stands that illuminate the bridge's northern approach.

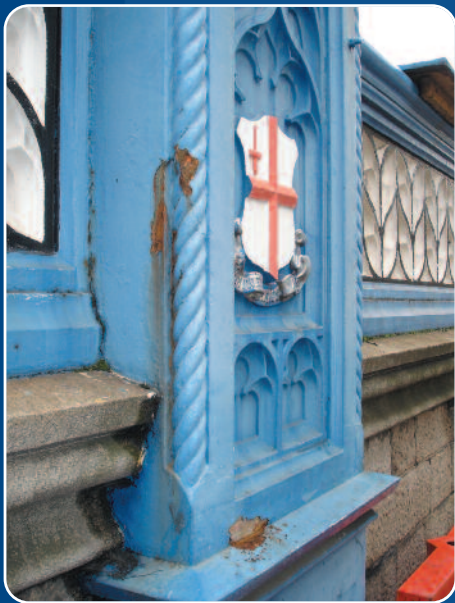
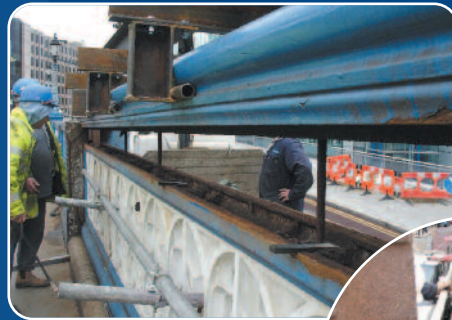
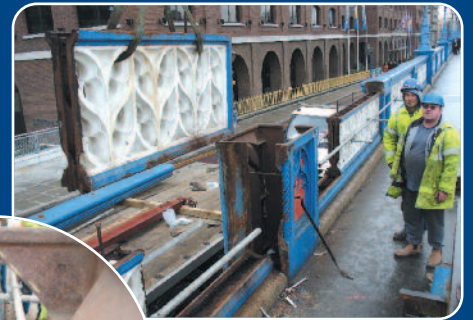
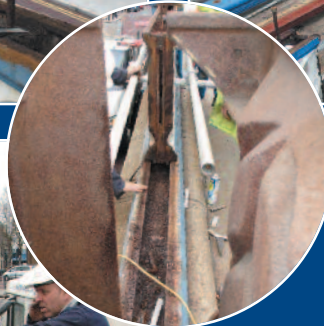
Structural problems were evident externally but stripping the balustrades and lamp stands down revealed more serious damage

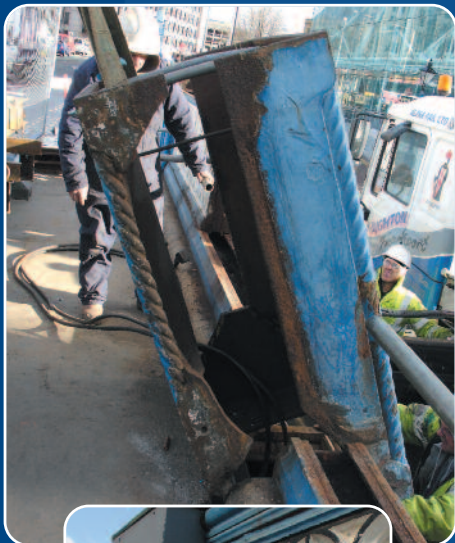
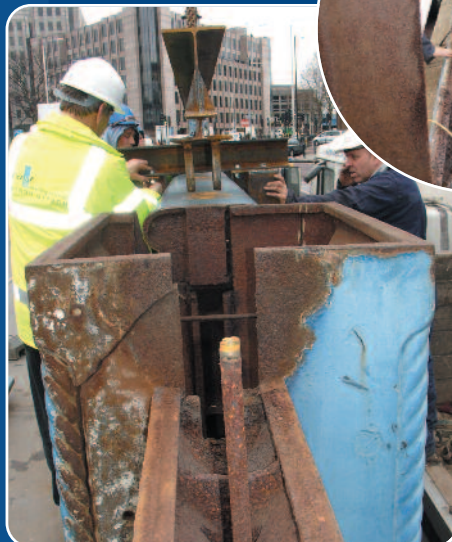
Each component was removed with utmost care, broken pieces were collected together ready for reconstruction at the factory.

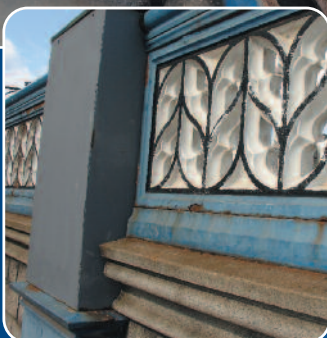
Temporary lamp bases were manufactured and installed whilst the originals were restored.

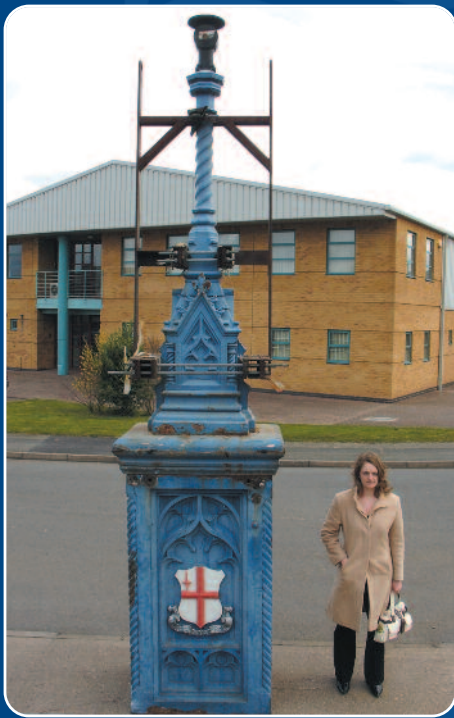
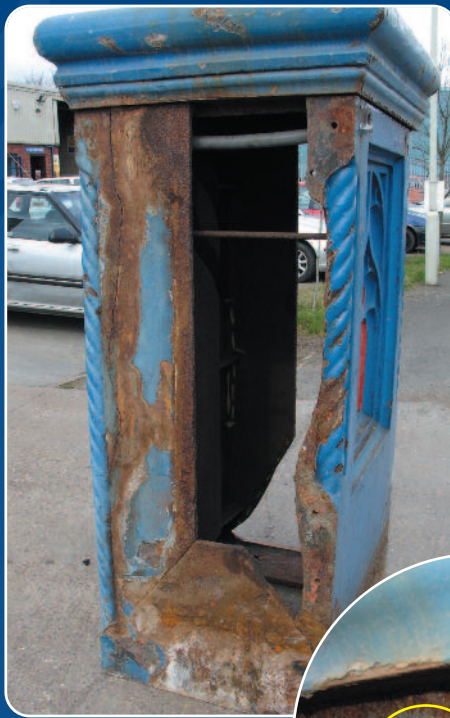
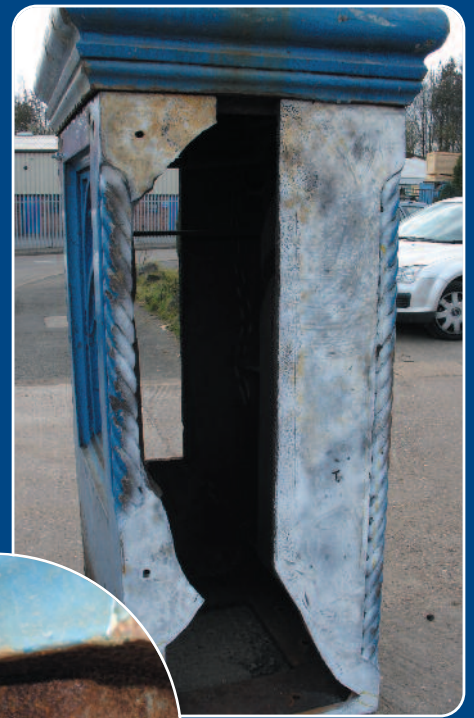
Back at the factory, the components were reassembled and carefully measured before being stripped of over twenty layers of paint!

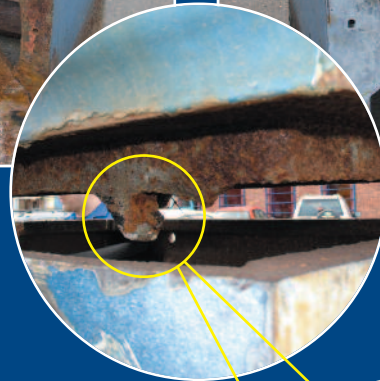
Broken lugs were found, re-welded and drilled to accept the original tie-rods.

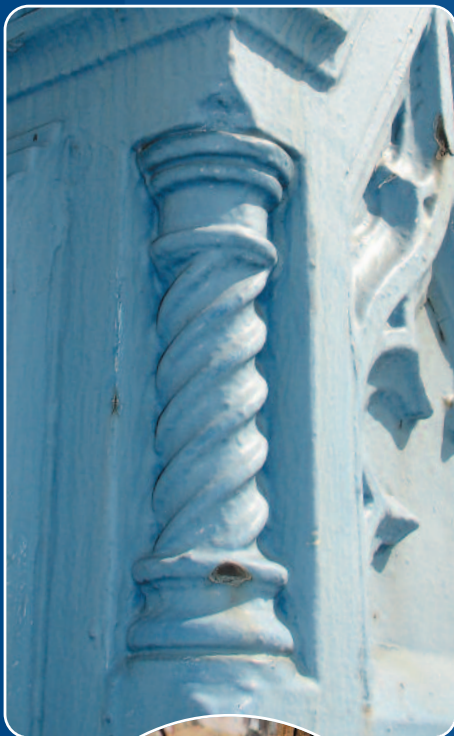
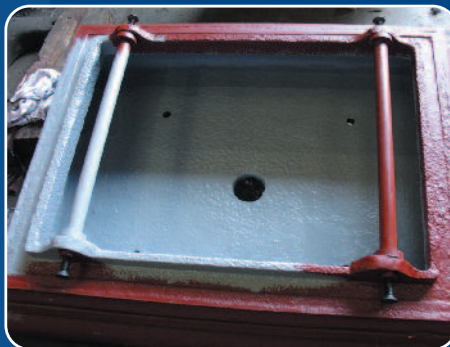
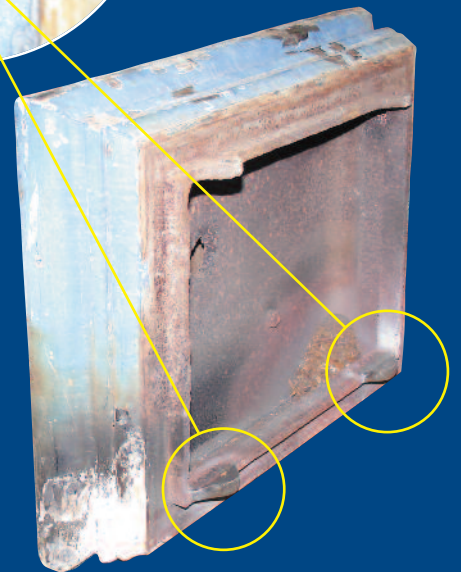
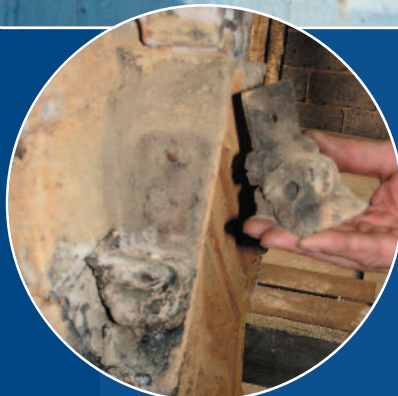
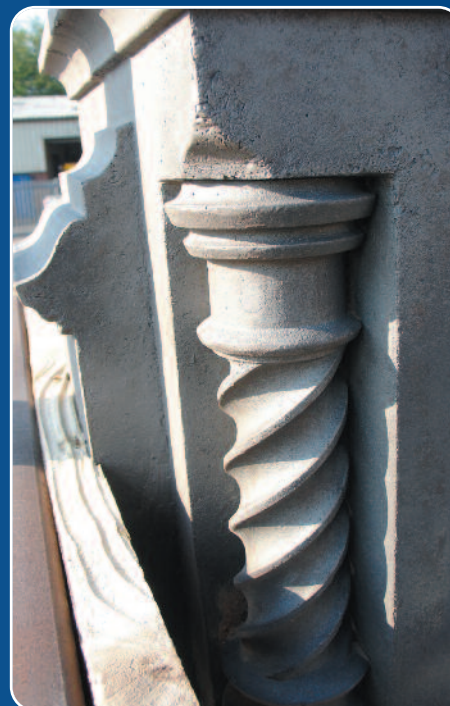
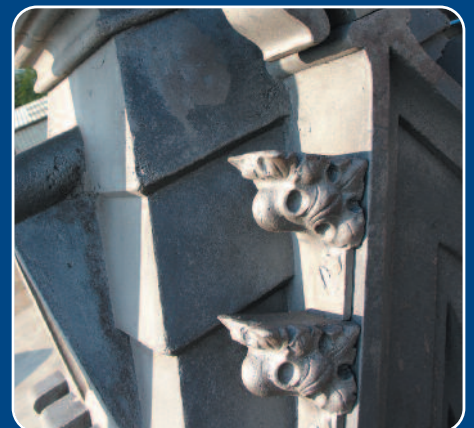
Stripping back a century of paint revealed the crisp detail of the original mouldings, some of which had to be re-attached due to cracking and corrosion.

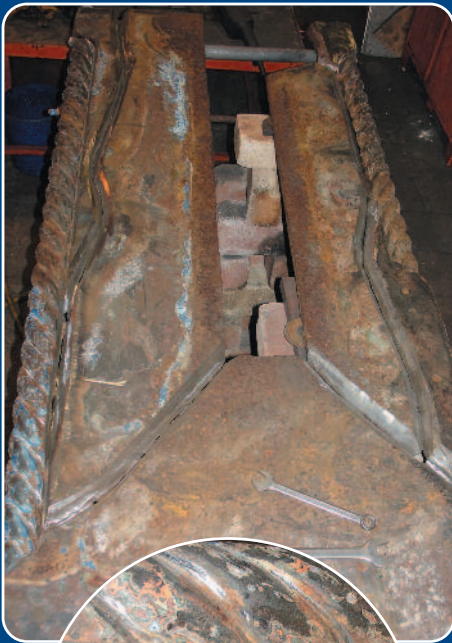
Gas fusion welding requires the composition of the iron in the damaged component to be analysed, enabling bespoke filler rods to be cast to achieve the repair. A custom-built furnace is constructed around the component within which the welding takes place. Heat is applied gradually to allow the furnace to reach a temperature of 580°C at which point the metal around the repair is melted and the filler rods fill the damaged area. The component is cooled gradually and the repair evaluated.

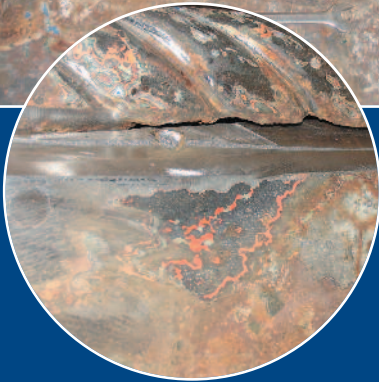
The damaged areas are ground out ready for gas fusion welding. The repair is then cleaned up ready for final machining and painting.

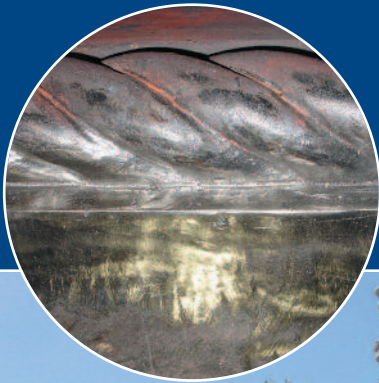
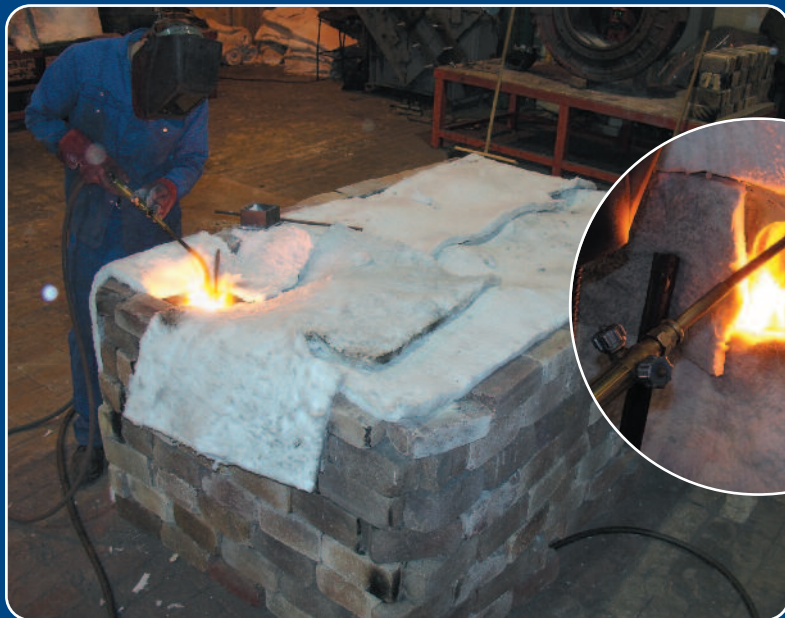
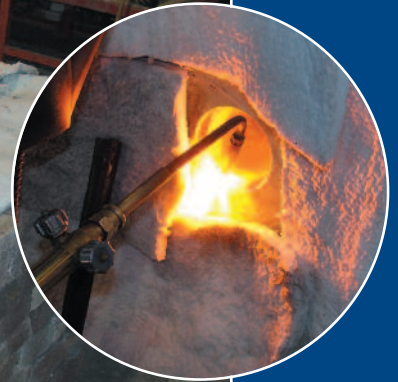
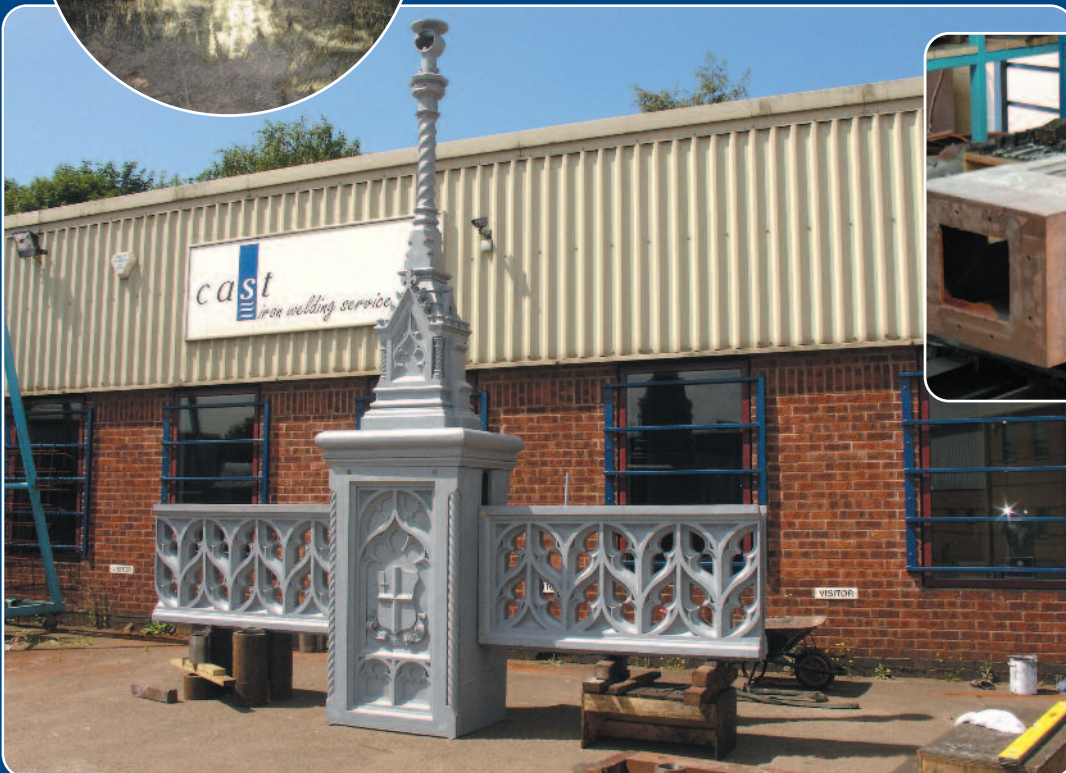
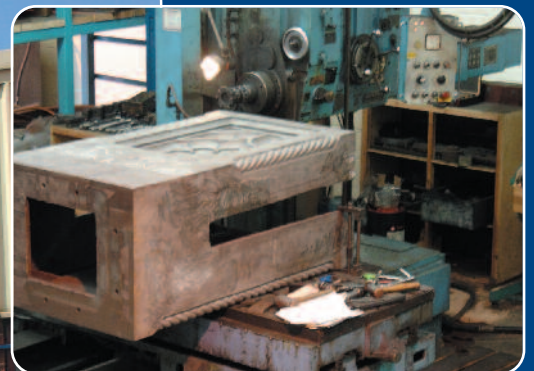
The repaired components are bolted together and if necessary machined true. Finally each component is primed, rebuilt and measured for fit.

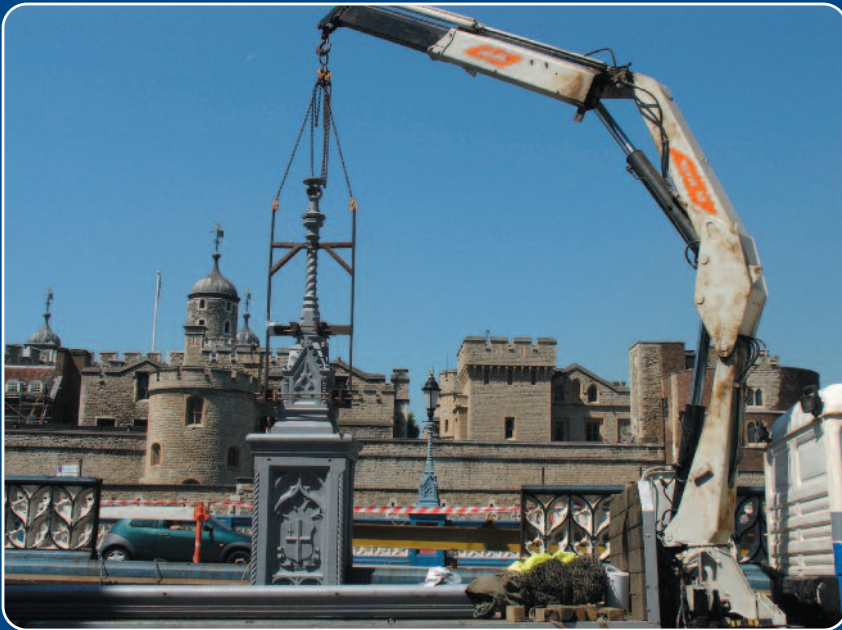
The restored lamp stand was carefully lifted back into place.

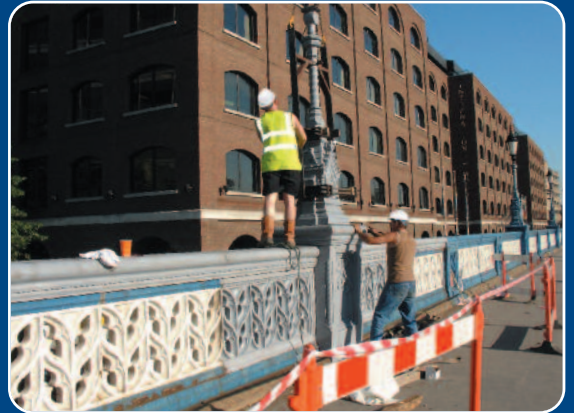
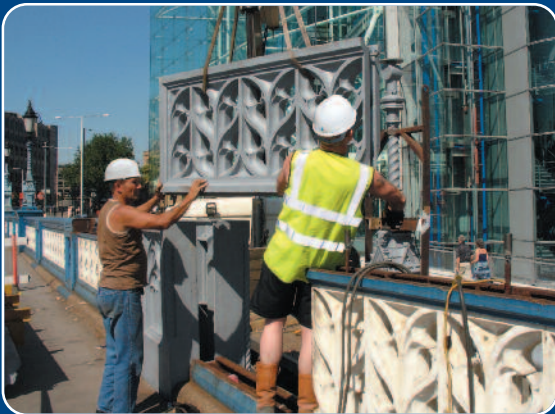
The balustrades are slotted into position followed by the capping rail.

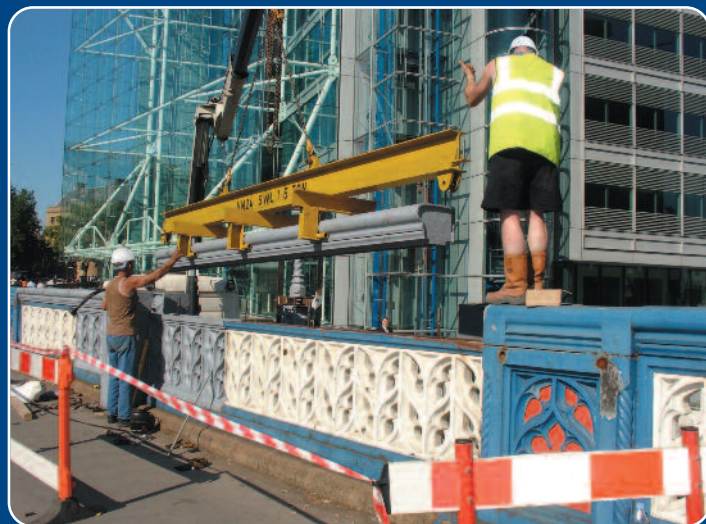
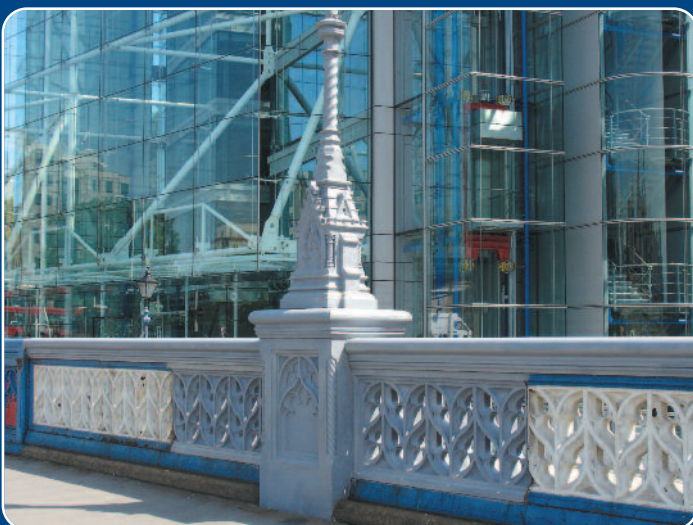
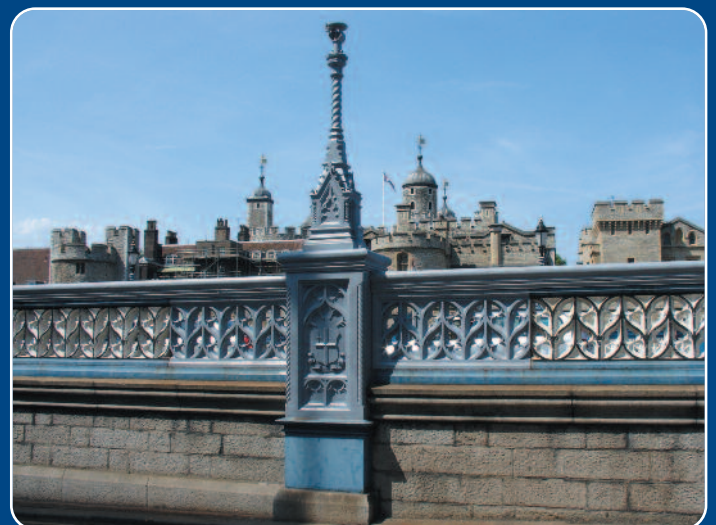
The restored balustrade and lamp stand ready for final painting.
