Cast Iron Repairs by Gas Fusion Welding

FRACTURES • CORROSION • EROSION

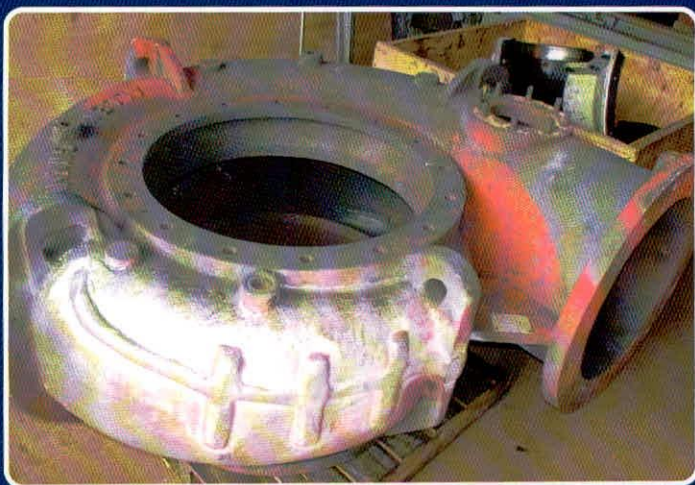
The component is then prepared for welding by removed the crack in it s entirety and to then establish a firm base of sound parent metal upon which to commence the welding process.
